Corrosion of Steel Fibre Reinforced Mortars - A Microstructural Investigation

A thesis submitted for
Masters of Engineering
Centre for Sustainable Infrastructure
Faculty of Science, Engineering and Technology
Swinburne University of Technology
Australia

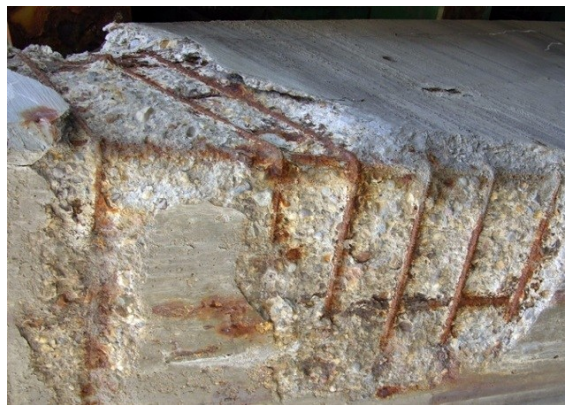
Figure 1. 3: Typical view of corrosion of steel reinforcement (spalling) in concrete (ACI)

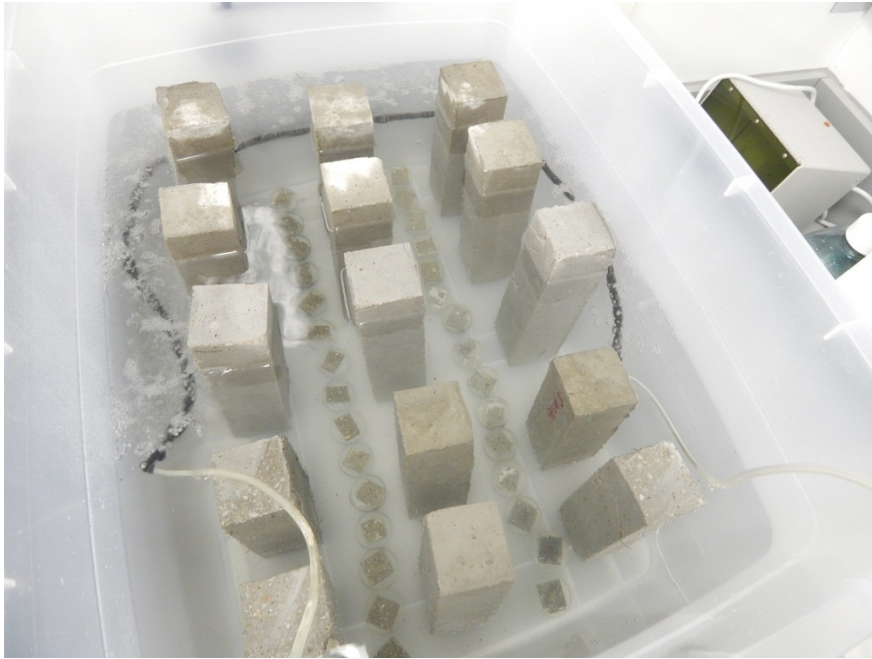
Figure 2. 7: Experimental setup used for immersion of the steel fibre reinforced mortar samples in aerated seawater.

In order to replicate marine conditions, the prisms and polished specimens were placed in a large tank of seawater with an aerator running constantly (see Figure 2.7).

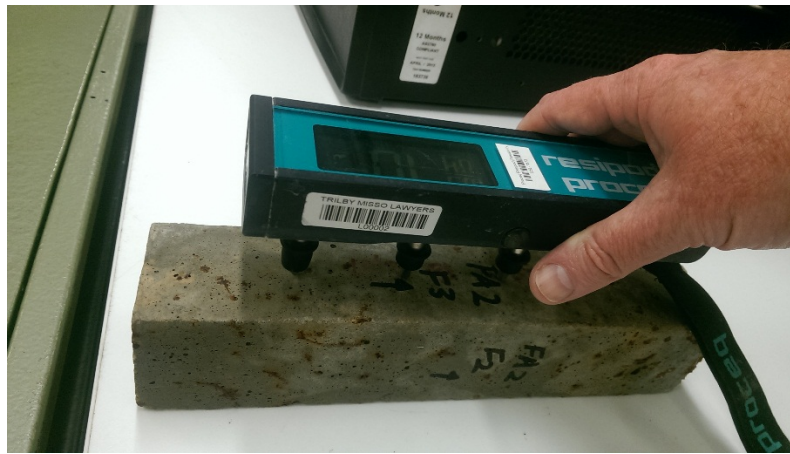
Figure 2. 8: The Proceq probe used to take electrical resistivity readings on a typical steel fibre reinforced mortar prism

The main data being collected throughout the period of immersion was the electrical resistivity of the prisms. This was achieved by first removing the prisms from the tank one at a time. They were then **dried** with a cloth to removed excess moisture and placed lengthwise on a bench with more cloth underneath the prism. A Proceq Resipod 4-probe Wenner device (Figure 2.8) was used to measure electrical resistivity on each face (excluding the ends). For the cementitious mortars two measurements were taken on each face, giving a total of 8 readings for each prism. For the geopolymer, each face was only tested once. This was because the geopolymer was highly consistent and very little change throughout the immersion whereas the other two materials had more variation from face to face and prism to prism.

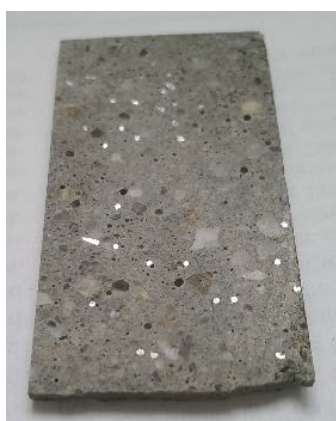
Figure 2. 10: Typical cross-section used for fibre count. The shiny steel fibres are clearly visible in the mortar.

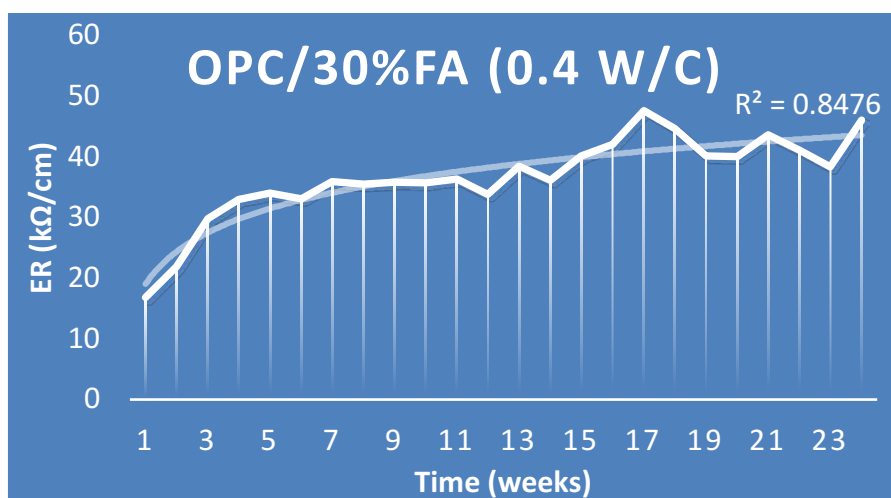
Figure 2. 14: Electrical resistivity readings of FA0.4 immersed in aerated seawater

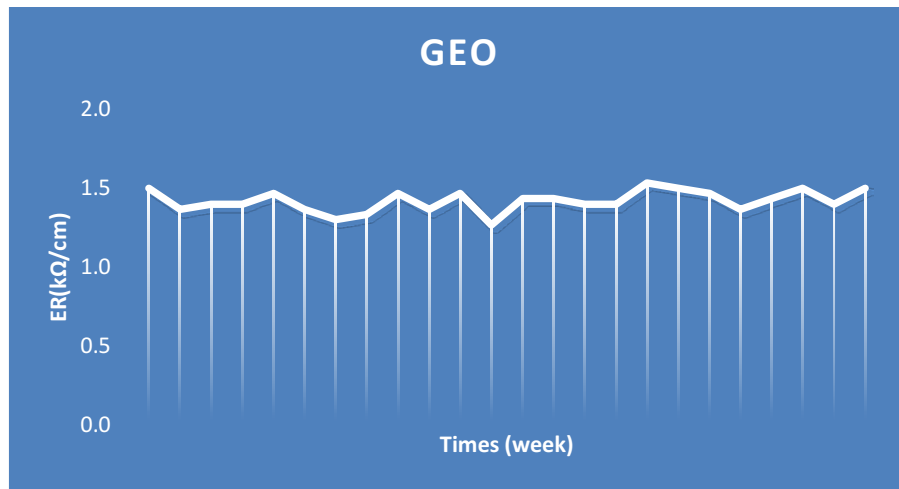
Figure 2. 15: Electrical resistivity readings of GEO immersed in aerated seawater

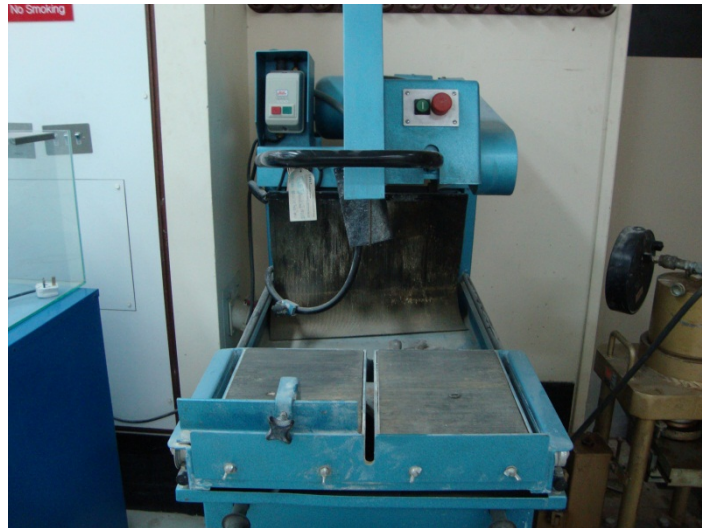
Figure 3. 1: Concrete saw for cutting mortar prisms

Prisms were placed on a concrete saw (Figure 3.1) and sliced through. At least two slices were performed on the prisms selected in order to produce a section of prism that could be fitted to the specimen holder on the fine diamond saw.

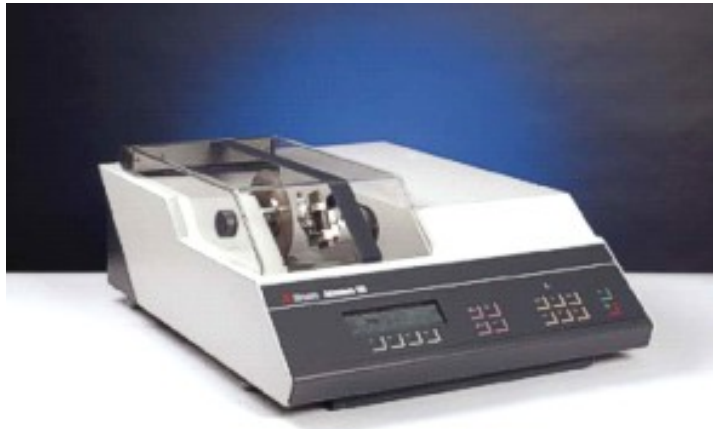
Figure 3. 2: Struers Accutom 50 for cutting thin sections of the prisms

The finer slicing was performed on a Struers Accutom 50 (Figure 3.2). Approximately 25mm x 25mm x 10mm sections were produced from the 9 prisms (three from each material). A minimum of 5 sections per prism were cut on the Accutom. These small sections were mounted in epoxy resin with the diamond cut surface exposed.

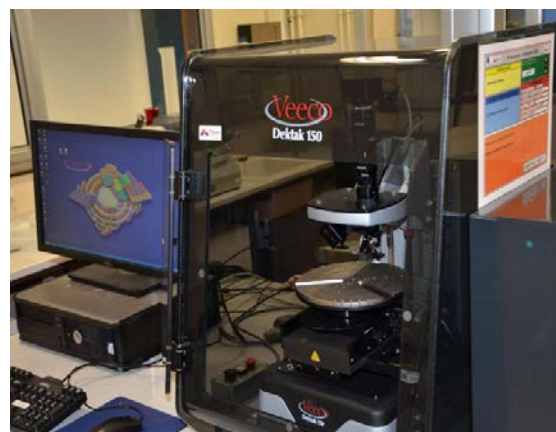
Figure 3. 4: Veeco Dektak 150 Profilometer

Optical microscopy was performed on the Olympus BX61 microscope (left) and 3D profiling was performed on the Veeco Dektak 150 profilometer (right)

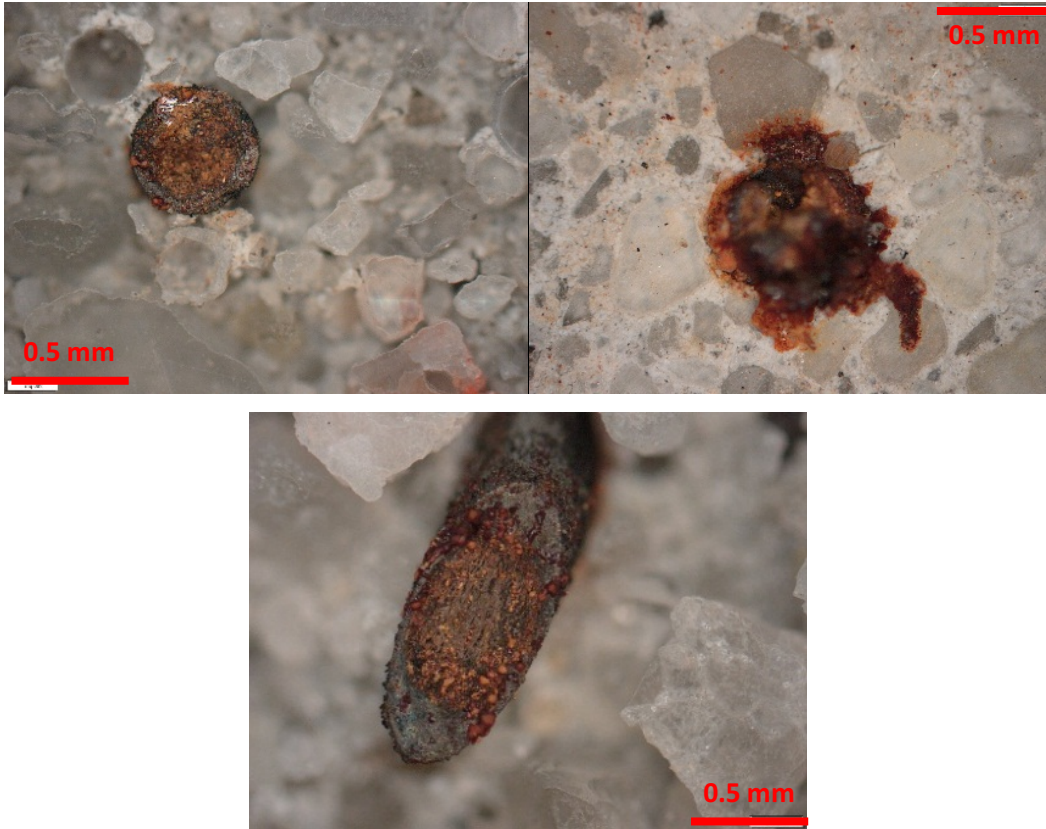
Figure 3. 17: Fibres in the OPC (left) and FA (centre and right) matrix after 4 months of immersion

At the 4 month stage, however, differences appear between the OPC mortar and the FA mortar. The way in which material builds up on the surface of the specimens and then is subsequently removed by cleaning does appear to follow different patterns between the two materials over time. This is especially the case at the end of the immersion period (6 months) where the OPC is much harder to clean and expose the fibres. Consequently, no pitting data was able to be retrieved from these samples. Therefore, only data from the FA and GEO samples are given for the end of immersion (6 months). This facet will be covered in more detail in Chapter 4.

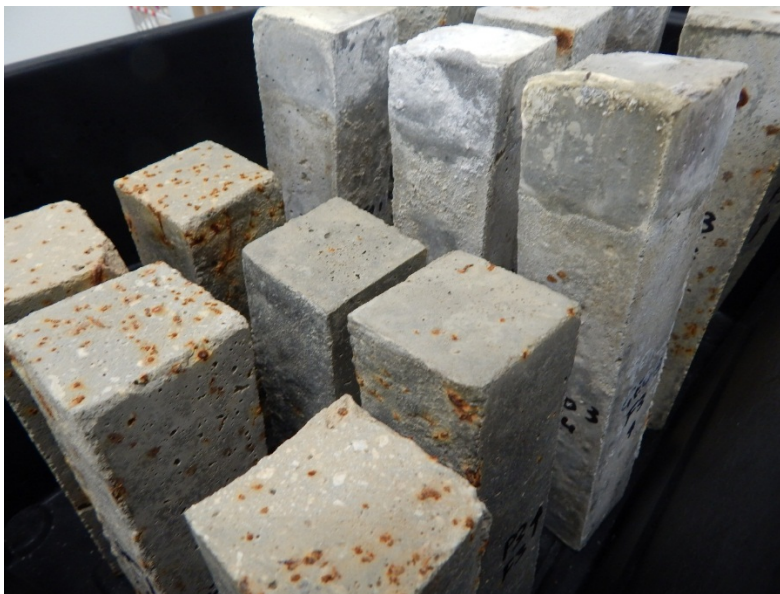
Figure 4. 1: The 15 test prisms immersed in aerated seawater for 6 months shown after removal from the tank at the end of the experiment

The fabrication of the steel fibre reinforced mortar prisms, curing and subsequent immersion was covered in Chapter 2. After 6 months of immersion the prisms were removed from the tank and allowed to air dry standing in the same formation they had been in the tank (see Figure 4.1).

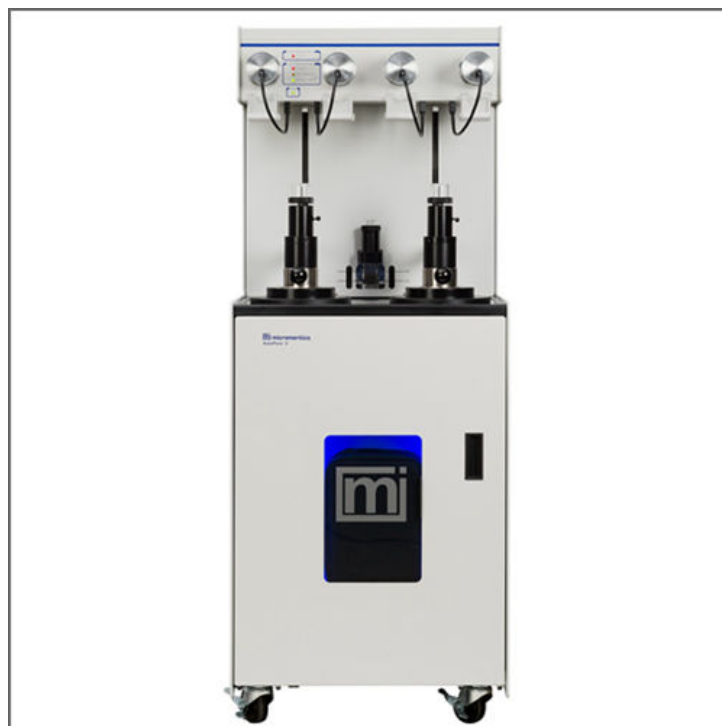
Figure 4. 2: The Auto Pore IV 9500 mercury intrusion porosimeter

For the microstructure analyses conducted in this section both polished specimens subjected to immersion and ones taken from the post-immersion prisms were used. The details of preparation of the polished specimens placed in the tank for immersion was outlined in Chapter 3. For the new specimens, small fragments were taken from three of the prisms (one from each binder type) and sent for analysis by mercury intrusion porosimetry (MIP) to an external laboratory. Approximately 1g of each of the three mortar types was used for analysis on the Auto Pore IV 9500.

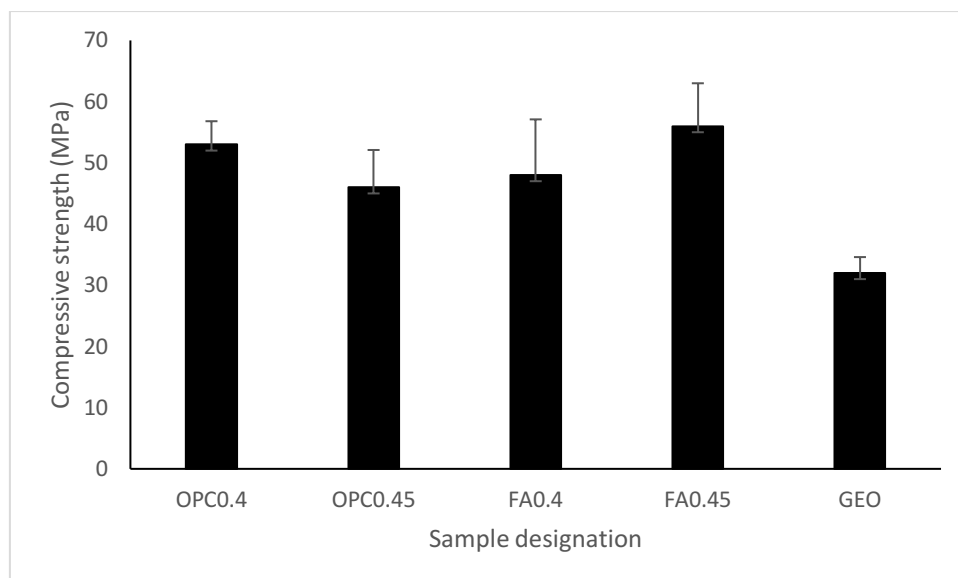
Figure 4. 4: Compressive strength values for each mortar formulation (pre-corrosion)

Three cubes from each mortar type were tested after 28 days of ambient curing. The results (with error bars) in MegaPascals (MPa) are given in Figure 4.4 for the five different formulations (the two cementitious binders at water-cement ratios of 0.4 and 0.45 along with the geopolymer one).
