# Seismic Performance of a Brick Veneer Steel-Framed House

Vidal P. Paton-Cole<sup>1</sup>, Emad F. Gad<sup>2</sup>, Charles Clifton<sup>3</sup>, David J. Heath<sup>4</sup>, Carl Davies<sup>5</sup>,  
Stephen Hicks<sup>6</sup> and Nelson Lam<sup>7</sup>

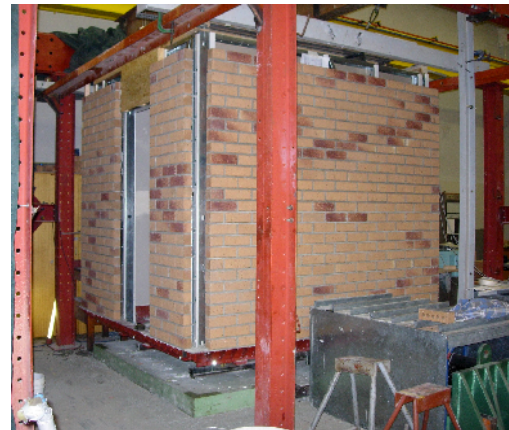
(b) Completed Test specimen

Figure 1. Test House geometry

The Test House was designed such that it encompassed a range of typical geometric features in the veneer walls in two different directions. It had two brick veneer walls without openings in one direction and in the orthogonal direction it had one wall with a window opening and the other wall with a door opening. Since the primary objective of the test was to examine the out-of-plane performance of the brick veneer walls, the brick walls were not connected at the four corners of the Test House. This was to ensure that the ultimate inertia load effect of the out-of-plane walls would be fully imposed on the ties. As testing was performed in both directions, each veneer wall could be treated as one specimen, and the geometric configurations would be equivalent to testing three (3) different cases: walls with no opening, wall with a window opening and a wall with a door opening. A plan of the Test House is shown in Figure 1a and Figure 1b shows the completed Test House.

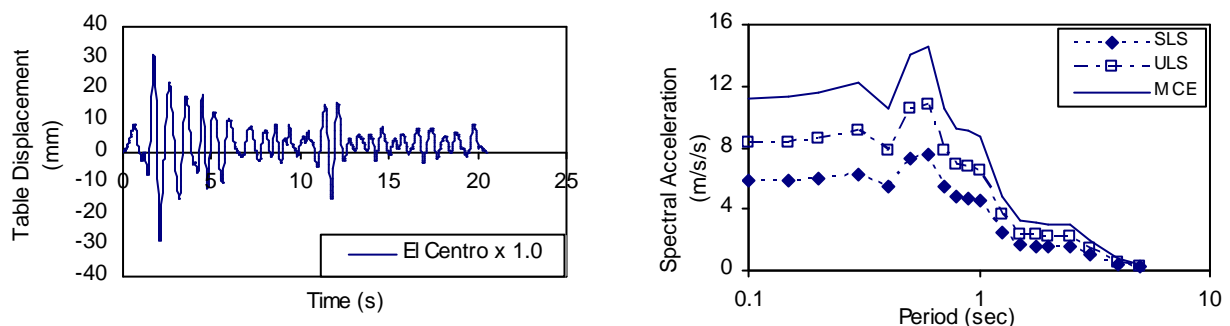
Figure 2: Selected input excitation: (a) El-Centro displacement-time history and (b) Response spectra for design earthquakes

Intermittently before and after each shaking table test, low level pulse and swept-sine inputs were used to characterise the dynamic properties of the Test House. Pulses of 5 - 20Hz and swept-sine input with a frequency range of 0.5-30Hz were imposed on the Test House using the shaking table. These were used to provide the basis for the evaluation of the modal parameters of the Test House. Prior to the earthquake shaking, it was found that the Test House had a natural frequency of approximately 6Hz, which lies within the high energy content of the El-Centro earthquake as shown in Figure 2b. It could therefore be concluded that the selected record was appropriate for the testing schedule.
